**Flood Control Project Maintenance
Levee Inspections**
LMA District Cover Sheet
Spring 2017 Levee Inspection Results

Reclamation District No. 0817 Carlin

Spring 2017 Levee Inspection Results

Waterway			Bank	Unit Miles
Unit No. 01 South Dry Creek			Left	3.81
	Spring (March - May)	Summer (June - August)	(September - November) Fall	Winter (December - February)
Unit Maintenance Rating (Fall Only)				
Date of Inspection	4/27/2017 - 4/27/2017			
DWR Inspector	Sterling York			
Accompanied By	Joe Conant RD 817

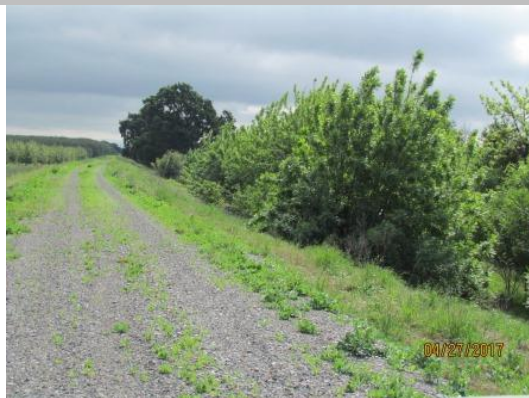
Photo 1 of 1 : SP_2017_RD0817_13_14_20170428_00022.jpg

LM Start	0.03	Rating **	M	Issue No.	14
LM End	3.86	Issue Type +	Ma	Location *	WS
Category	Earthen Levee			GPS Latitude/Longitude	
				Start	End
Item	Vegetation			38.984355 °	38.993400 °
				-121.505750 °	-121.437366 °
DWR ID	DWR_RD0817_02_f_2016_14				
Comment Code					
V1 : Control annual grass and weeds on the levee slopes and easements.					
Inspector Comment					
Annual grass needs to be maintained, Spring2017.

View looking upstream of the annual vegetation that needs to be maintained, Spring 2017.

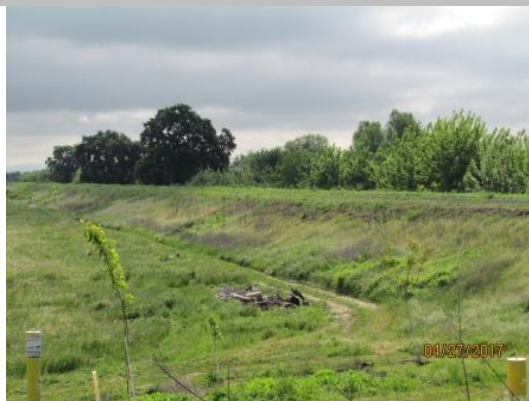
Photo 1 of 1 : SP_2017_RD0817_13_13_20170428_00021.jpg

LM Start	0.03	Rating **	M	Issue No.	13
LM End	3.86	Issue Type +	Ma	Location *	LS
Category	Earthen Levee			GPS Latitude/Longitude	
				Start	End
Item	Vegetation			38.984354 °	38.993400 °
				-121.505749 °	-121.437366 °
DWR ID	DWR_RD0817_02_f_2016_13				
Comment Code					
V1 : Control annual grass and weeds on the levee slopes and easements.					
Inspector Comment					
Annual grass needs to be maintained, Spring 2017.

View looking upstream of the annual vegetation that needs to be maintained, Spring 2017.

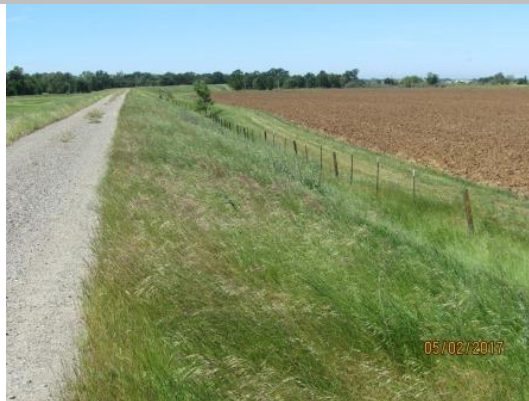
Photo 1 of 2 : SP_2017_RD0817_14_16_20170503_00032.jpg

LM Start	0.25	Rating **	M	Issue No.	16
LM End	1.27	Issue Type +	Ma	Location *	LS
Category	Earthen Levee			GPS Latitude/Longitude	
				Start	End
Item	Vegetation			38.987626 °	38.996896 °
				-121.506567 °	-121.491925 °
DWR ID	DWR_RD0817_03_f_2016_16				
Comment Code					
V1 : Control annual grass and weeds on the levee slopes and easements.					
Inspector Comment					
Annual grasses need to be maintained. Spring 2017.

View looking downstream of annual grasses that need to be maintained on the landside, Spring 2017.

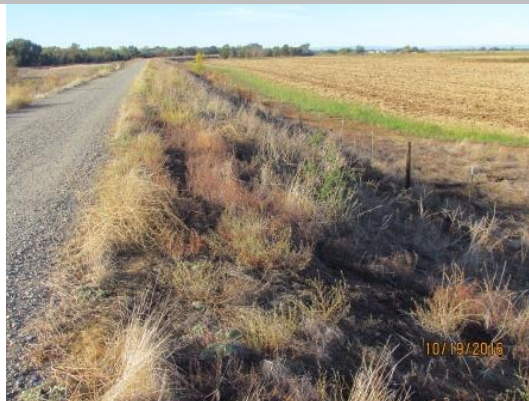
Photo 2 of 2 : SP_2017_RD0817_14_16_20170316_00008.jpg

LM Start	0.25	Rating **	M	Issue No.	16 (cont)
LM End	1.27	Issue Type +	Ma	Location *	LS

View of annual grasses that need to be maintained on the landside looking downstream. Fall 2016.
